Dealer Service Instructions for:

## Safety Recall H03 Front Control Module

2008 (WK) Jeep® Grand Cherokee

2008 (XK) Jeep® Commander

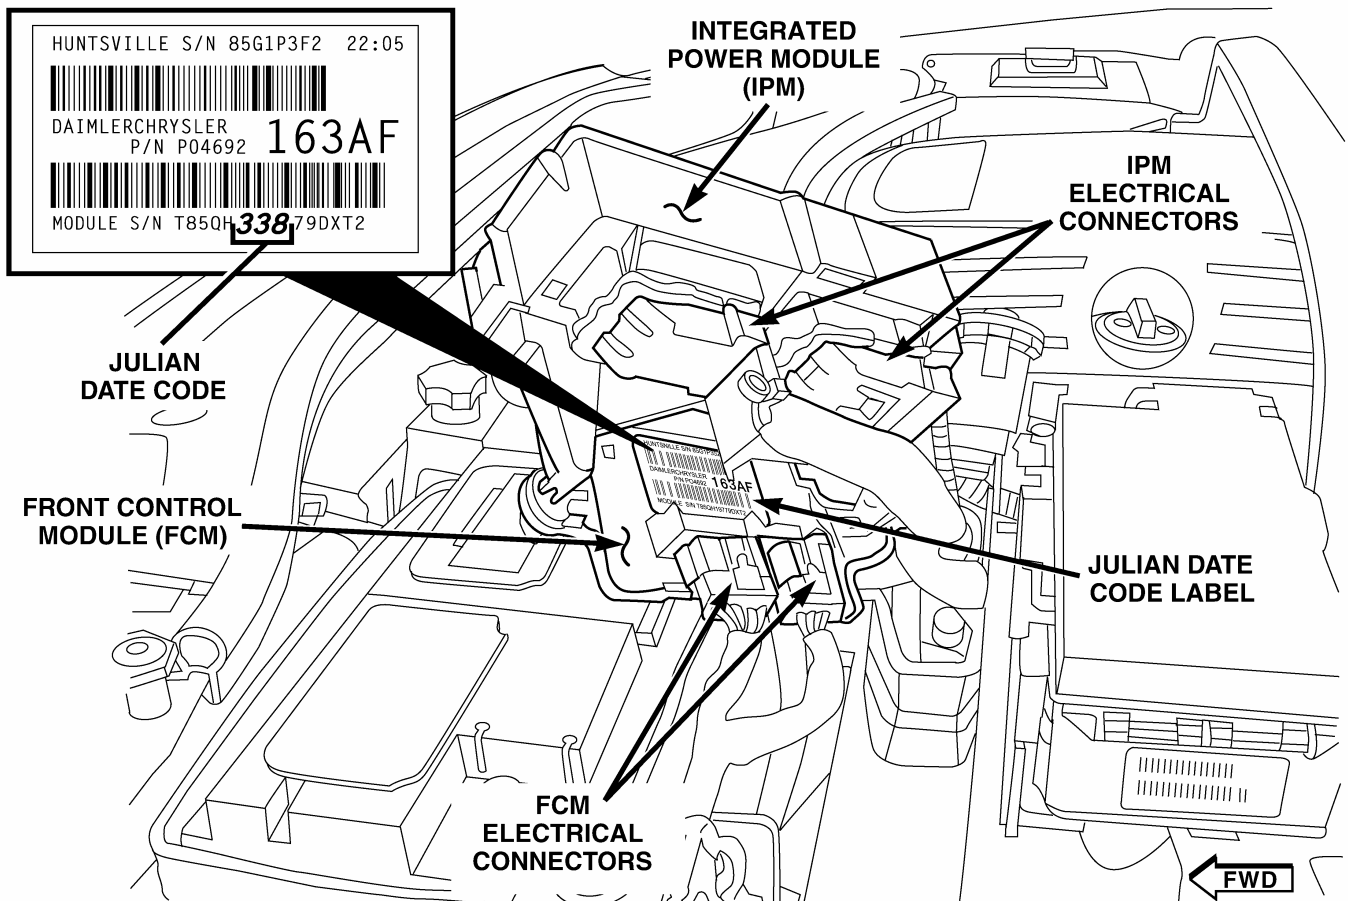
Figure 3

3. Inspect the Julian date code on the label located on the backside of the FCM (Figure 3).

**CAUTION: The FCM has two labels. One label is located on the front side of the FCM. The second label is located on the back side of the FCM between the module electrical connectors. The Julian date code label to be inspected is located on the back (electrical connector) side of the FCM.**

**NOTE: The Julian date is the 6<sup>th</sup>, 7<sup>th</sup>, and 8<sup>th</sup> character in the bottom row of numbers (Figure 3).**

- If the Julian date code is lower than 337 or higher than 339 the FCM **does not require replacement**. Continue with Step 15 of this procedure.
- If the Julian date code is 337, 338, or 339 the FCM **must be replaced**. Continue with Step 3 of this procedure.

4. Disconnect the two IPM electrical connectors (Figure 3).
5. Disconnect the two FCM electrical connectors (Figure 3).
6. Remove the IPM assembly from the vehicle.
7. Remove the four fasteners securing the FCM to the IPM (Figure 4).
8. Separate the original FCM from the IPM by pulling the two straight away from each other to disengage the electrical connector (Figure 5).
9. Transfer the plastic cover from the original FCM module to the new FCM module (Figure 4).
10. Connect the new FCM to the IPM by lining up the electrical connector and pushing the two modules together (Figure 5).
11. Install the four fasteners securing the FCM to the IPM (Figure 4).
12. Position the IPM into the vehicle.
13. Connect the two FCM electrical connectors (Figure 3).
14. Connect the two IPM electrical connectors (Figure 3).
