NUMBER: 08-029-11

GROUP: Electrical

Radio May Shut Down And Reset Intermittently

This bulletin involves updating the REW radios navigation map database software.

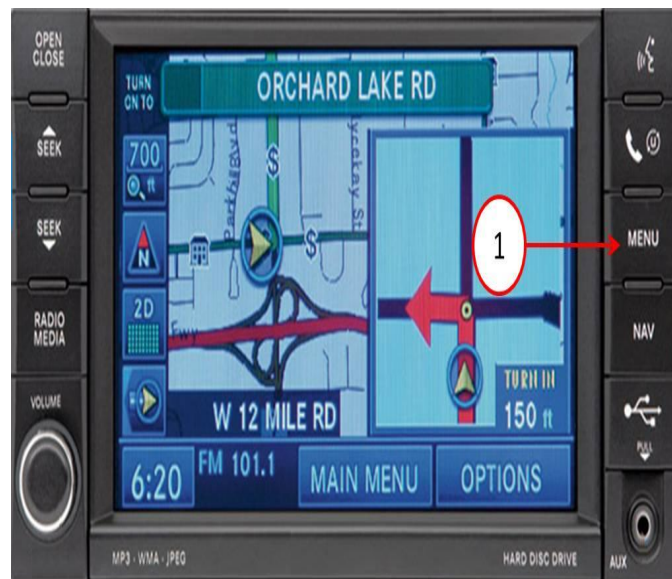
Fig. 1 Radio Face Plate

1 - MENU Key

1. Turn ignition to the RUN position
2. Turn the Radio on.
3. Press the MENU key (Fig. 1).

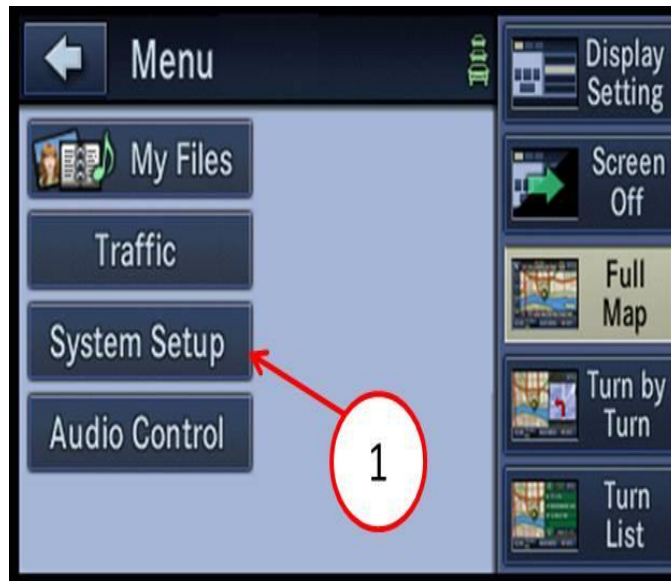
Fig. 2 Radio Face Plate

1 - System Setup

-
4. Press System Setup (Fig. 2).

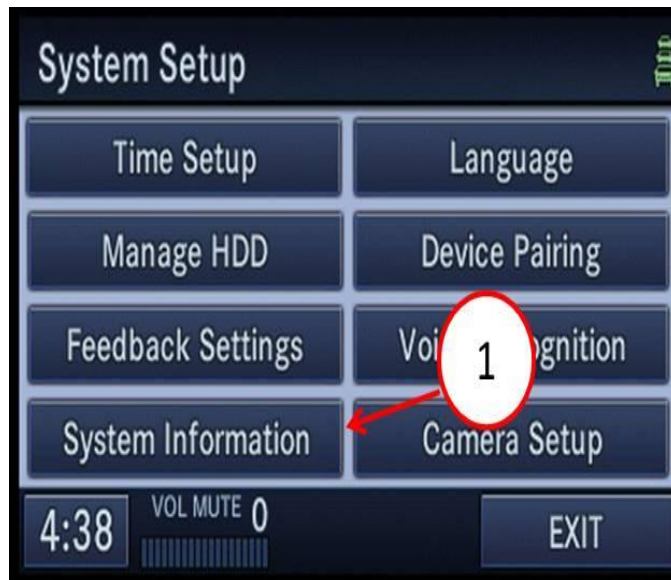
Fig. 3 Radio Face Plate

1 - System Information

5. Press System Information (Fig. 3).

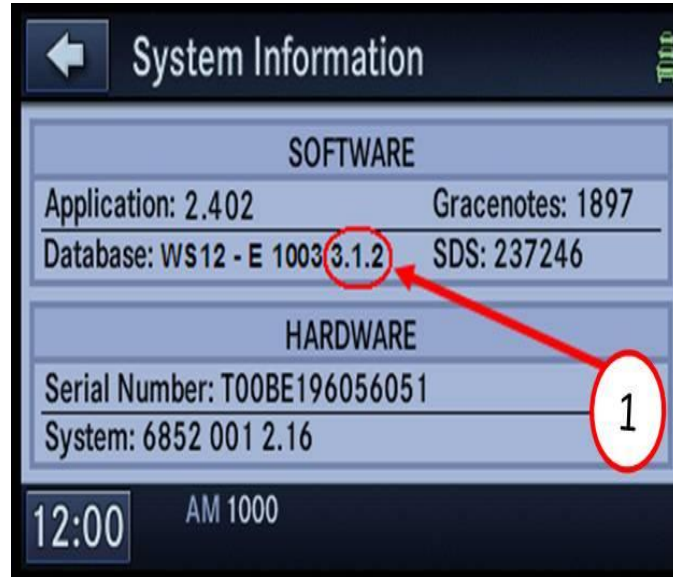
Fig. 4 Radio Face Plate

1 - Database version

6. Are the last 3 digits of the database 3.1.2 (Fig. 4)?
a. No >>> return the vehicle to the customer. The navigation database does not require an update.

b. Yes >>> proceed to [Step #7](#) .

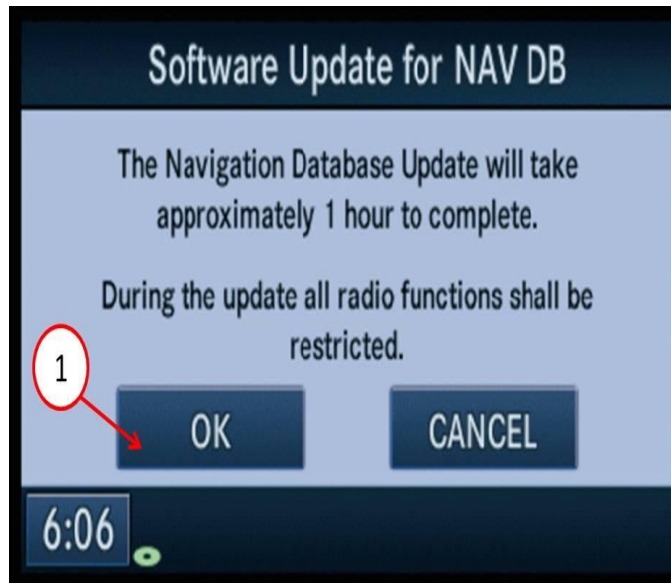
Fig. 5 Radio Face Plate

1 - Press OK

9. The radio will read the contents of disc and will prompt the user to select "OK" or "CANCEL" as shown in the screen below. It may take approximately 2 minutes for this prompt to display ([Fig. 5](#)).

-
- 10. Press "OK"(Fig. 5) .
 - 11. The next screen will display the current and new version of the Navigation Map database software.

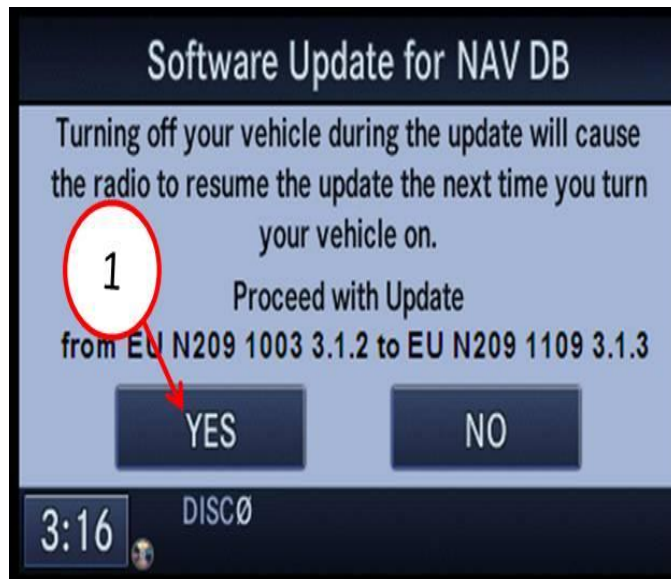
Fig. 6 Radio Face Plate

1 - Press Yes

-
- 12. Press YES (Fig. 6).

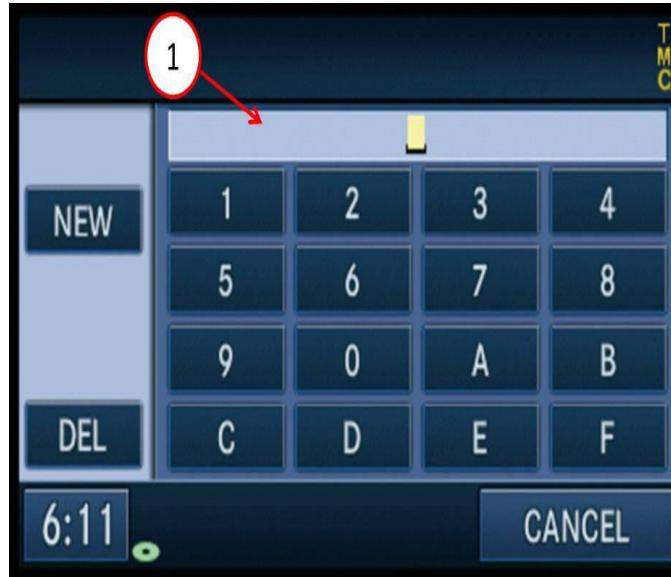
Fig. 7 Radio Face Plate

1 - Activation Key

13. When prompted by the radio enter the activation key obtained in [Step #7](#).

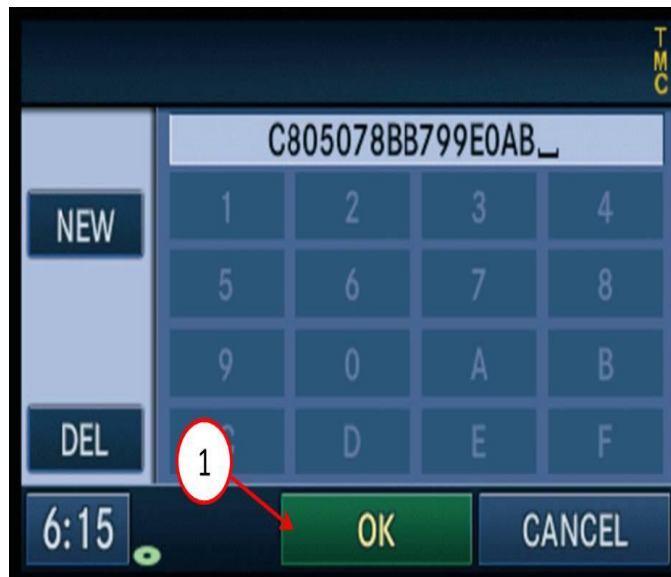
Fig. 8 Radio Face Plate

1 - Press OK

14. After successful entry of the activation key, the following screen will be displayed ([Fig. 8](#)).

15. Press "OK" and the update process will begin.

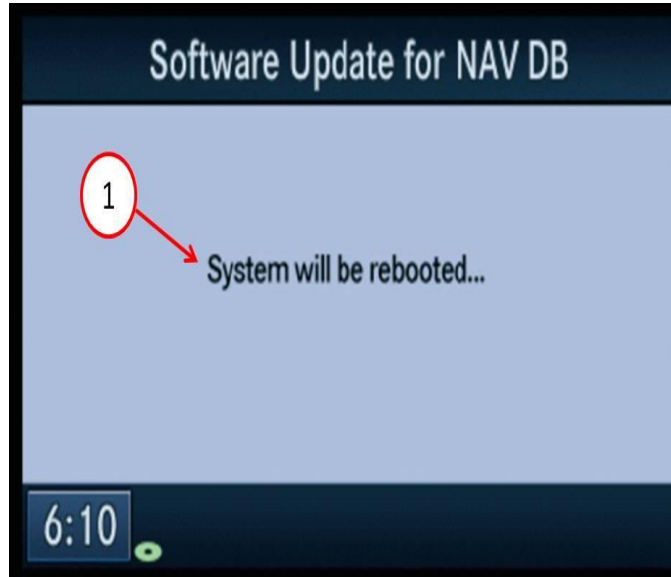
Fig. 9 Radio Face Plate

1 - System Reboot

16. The following screen will be displayed (Fig. 9).

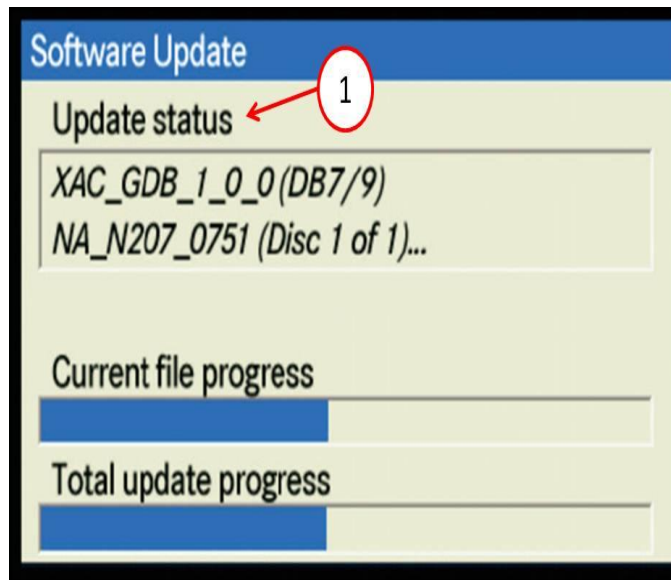
Fig. 10 Radio Face Plate

1 - Status

17. After the radio resets, the following screen will be displayed (Fig. 10)

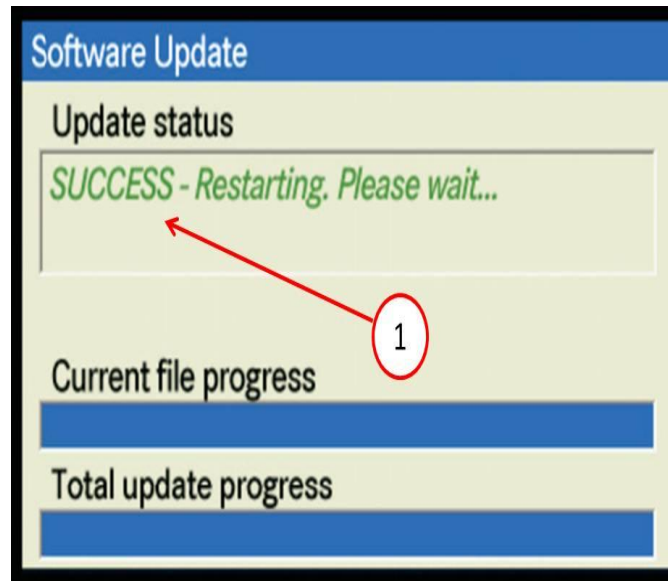
Fig. 11 Radio Face Plate

1 - Success

18. After successful update, the following screen will be displayed (Fig. 11)
