**NUMBER:** 08-004-05

**DATE:** January 26, 2005

Park Assist System - False Object Detected And Erroneous DTC's

2005 (WK) Grand Cherokee

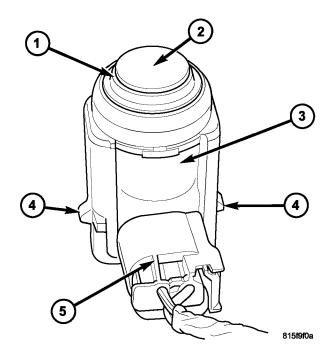
Fig. 1 PARK ASSIST SENSOR

- 1 Sensor Spacer Must Be Fully Seated On Clean Surface
- 2 Chrome Face Of Sensor Must Be Clean
- 3 Park Assist Sensor
- 4 Retention Clip Lands Both Must Be Engaged To Bracket Clips
- 5 Electrical Harness Connector
- Install the new sensor spacer. Verify that the spacer is correctly installed on the sensor and fully seated (Fig. 1).
- 14. Install the sensor with new spacer to the fascia bracket/applique. Hand effort may be higher than normal to fully engage the bracket retention clips to the sensor. Use hand pressure only to install.

12. Remove the old sensor spacer. With a clean rag thoroughly clean the sensor face and side, and the opening in the bracket for the sensor.

NOTE: Make sure the clips on each side of the sensor are fully installed to the bracket. Verify that the sensor bracket is fully installed to the applique clips.

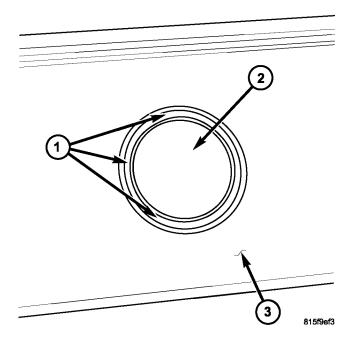
Fig. 2 SENSOR CENTERED IN FASCIA

NOTE: The sensor face of each sensor must be centered and not touching the chrome bracket/applique. The new spacer must be evenly spaced around the side of the sensor face.

- 1 Sensor Spacer Evenly Spaced Between Sensor And Applique
- 2 Park Assist Sensor Face Centered And Not Contacting Chrome Applique
- 3 Fascia Chrome Applique

- 15. Replace the spacers on the remaining three sensors.
- 16. Looking at the face (outside surface) of the fascia, inspect the face of each sensor to insure that it is centered in its opening and is not contacting the bracket/applique. Inspect each spacer to ensure that it is evenly spaced between the sensor and bracket/applique (Fig. 2).
