NUMBER: 23-010-05

Rattle-Like Sound From Instrument Panel Due To Loose Air Outlet To Duct Fit

2005 (WK) Grand Cherokee

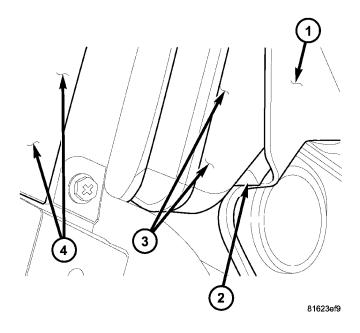
Fig. 1 SIDE AIR OUTLET DUCT & BRACE

While driving, the customer may experience a rattle-like sound coming from the left or right side of the instrument panel. Closer inspection may reveal that the rattle-like sound is coming from the far left and/or far right air outlet.

This condition may be caused by a loose interference fit between the back of the air outlet and the connecting plastic air duct located behind the air outlet.

- 2. Locate the connection between the back of the far right side air outlet and the air duct. A foam stuffer will be made out of the double back tape. The foam stuffer will be installed between the bottom side of the air outlet duct and the instrument panel brace. Prep these surfaces to accept the foam stuffer adhesive by making sure the surfaces are clean of any dirt, dust, or oils (Fig. 1).

- 5. Remove the adhesive protective backing from both ends/sides of a foam stuffer.
- 6. Install the foam stuffer between the bottom of the air outlet duct and the instrument panel brace. Verify good adhesion of the stuffer.
