NUMBER: 23-032-07

Front Door Window Glass - Loose, Sticks, Binds, or Express-Up Reversal

2006-2007	(WH)	Grand Cherokee (International Markets)
2006-2007	(WK)	Grand Cherokee
2006-2007	(XH)	Commander (International Markets)
2006-2007	(XK)	Commander

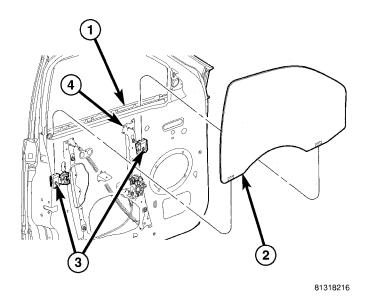
Fig. 4 REGULATOR CLAMPS AND DOOR GLASS

- d. Position (lower) the window regulator so that two regulator glass clamps can be thoroughly inspected.
 - e. Inspect each clamp and verify that the **rubber pad** between each clamp is installed correctly to the clamp. During a prior installation, the sides of some pads may have been dislodged and forced into the bottom of the clamp. Adjust the rubber pads as required (Fig. 4).

- f. Remove the temporary tape and carefully lower the glass into the open clamps. Make sure the plastic plates, (if equipped) on the lower edge of the glass **or** the edge of glass (if not equipped with plastic plates) properly engage the clamps.

- g. Carefully raise the window regulator until it is almost to its full up position and slide the glass against the B-pillar window channel. Bring the glass and regulator to the full up position (window closed). Make sure glass is fully seated against B-pillar side of window frame weatherstrip prior to tightening the glass clamp bolts.

- h. Tighten both glass clamp bolts to 11.8 N-m (105 in. lbs).
- i. Verify that the door glass and window regulator operate properly.
