NUMBER: 24-001-10

DATE: January 12, 2010

Rear Defroster Switch Engagement Effort

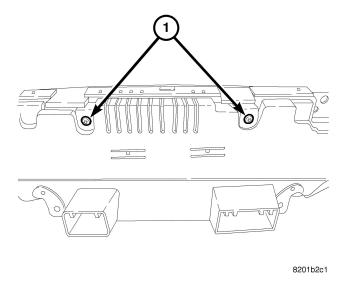
Fig. 1 ATC HEAD SCREW LOCATIONS

Customer may experience a rear defroster switch that has higher than desired engagement effort. This condition is caused by the ATC housing having too much deflection when the button is pressed which does not close the switch properly. Extra push effort will close the switch.

1 -Screw Location

- Remove the ATC Control head. Follow the detailed service procedures available in DealerCONNECT/TechCONNECT, Refer To Group 24 - Heating & Air Conditioning > Controls > Controls, A/C and Heater Removal procedures.
- 2. Install the two screws into the back of the ATC control head p/n 68078941AA (Fig. 1).
