SUBJECT: Rapid Response Transmittal Service Action #04-029
Structural Dust Cover Bolt May Contact Oil Pan

INVOLVED VEHICLES: 2005 (WK) Grand Cherokee

NOTE: This service action applies to vehicles equipped with a 5.7L engine (sales code EZB).

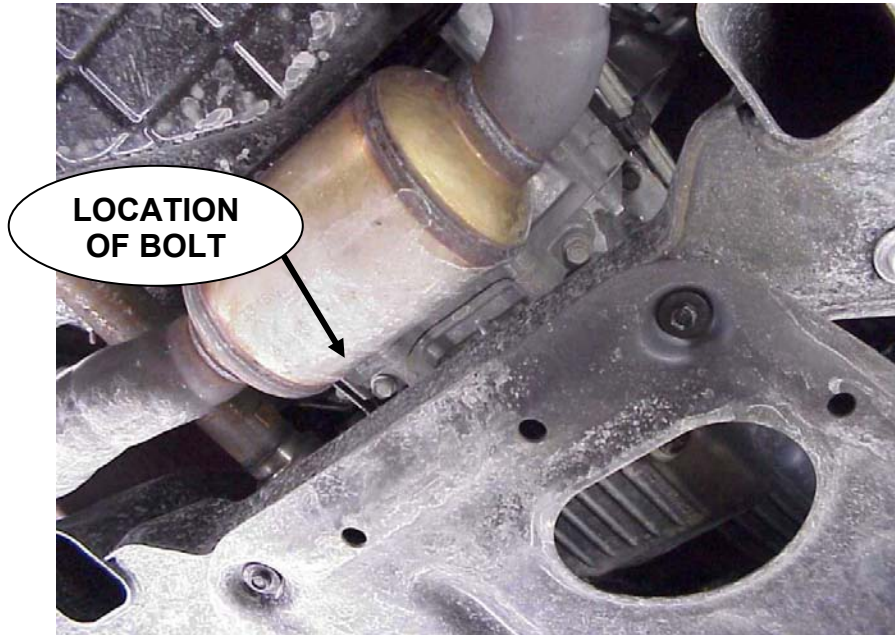
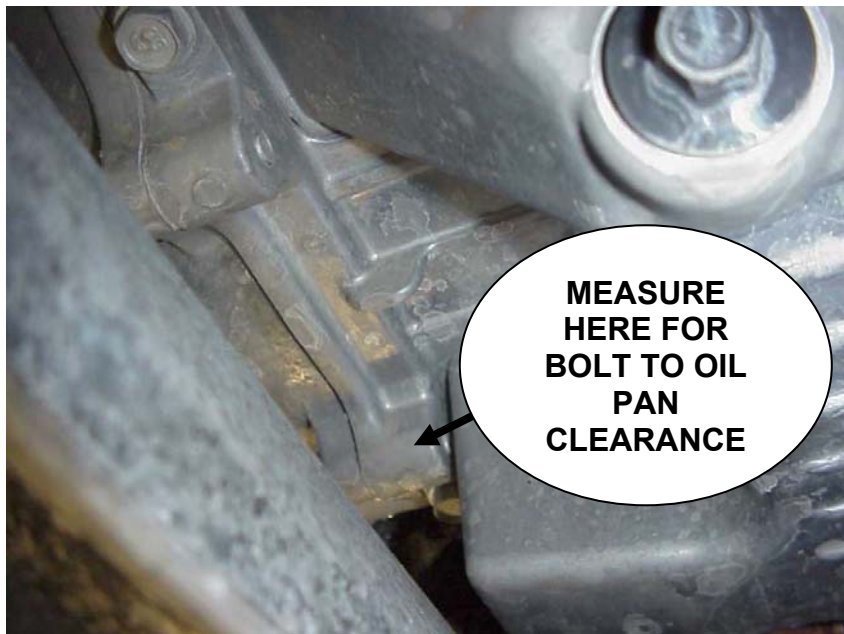
A number of Grand Cherokees with 5.7L engines (EZB) may have been built with a structural dust cover bolt that may be too long. If the bolt is too long, it may come in contact with the engine oil pan. A bolt that is too long may cause damage to occur to the cast engine oil pan.

1. Raise the vehicle on a suitable lift.
2. Locate the suspect transmission inspection cover bolt at the back of the engine oil pan on the left (driver) side of the vehicle.

3. Inspect the head of the suspect bolt. If the number on the head of the suspect bolt is a “9.8”, then there should be no interference issue. Verify clearance, lower vehicle, and return to customer.

4. If the number on the head of the suspect bolt is a “10.9”, then there may be an interference issue between the end of the bolt and the engine oil pan.

5. Using a 0.025 mm (0.001 in.) thick feeler gauge, determine if the feeler gauge can pass between the end of the “10.9” bolt and the engine oil pan.
6. If sufficient clearance of 0.025 mm (0.001 in.) or more is present between the end of the incorrect (“10.9”) bolt and the engine oil pan, then perform only step 1 of the Repair Procedure (replace the bolt).

7. If the incorrect structural dust cover bolt (“10.9”) is in contact with the engine oil pan, then perform step 2 of the Repair Procedure (replace oil pan and bolt). Verify part availability prior to disassembly.

1. Replace the structural dust cover bolt. Tighten to 54 Nm (40 ft. lbs.).
2. Replace the engine oil pan and the structural dust cover bolt. Refer to the Technical Information (9 – Engine / Lubrication / Oil Pan / Removal / Oil Pan) on TechCONNECT for detailed removal and installation procedures.
