**SUBJECT:** RAPID RESPONSE TRANSMITTAL #08-049 Excessive Gap between Cowl Screen and A-Pillar On The Left Side Of Vehicle

2008 (WK) Grand Cherokee

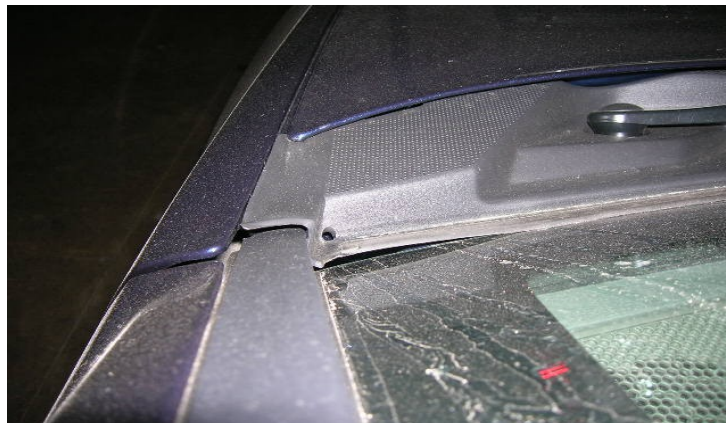
**Figure 1 – Cowl Gap**

A number of vehicles were shipped that may have an excessive gap between the cowl screen and a-pillar on the left side of the vehicle. If the gap is greater than 2.5 mm the left side cowl screen must be replaced.

1. Using a feeler gauge measure the gap between the left side cowl screen and the A-pillar.
2. Is the gap greater than 2.5 mm?
  - a. Yes >> proceed to step 3.
  - b. No >> Repair is complete.
3. Replace the left side cowl screen. Refer to the detailed removal and installation procedures available in DealerCONNECT > TechCONNECT under: Service Info > 23 – Body > Exterior > Panel - Cowl Top.
