August 5, 2008

**SUBJECT:** RAPID RESPONSE TRANSMITTAL #08-060  
Front Window Belt Molding Noise, Loose or Sticking

2008 (WK) Grand Cherokee

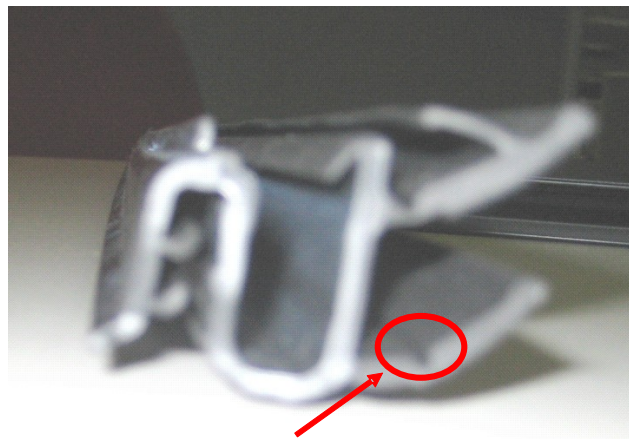
FIGURE 1

A number of vehicles were built with a front door window belt molding that can exhibit a moan sound or may stick and bind or become loose. Dealers are required to modify the belt molding on both doors.

Cut inner belt seal lower seal lip by the notch.

1. Roll both the front windows down fully.
2. Insert a sharp, slim razor knife into the slot near the lock knob and cut the inner belt molding's lower seal lip by the notch. (Fig 1).
