RADIO REMOVAL: 2005-2010 LX

CHRYSLER 300

DODGE CHARGER / MAGNUM

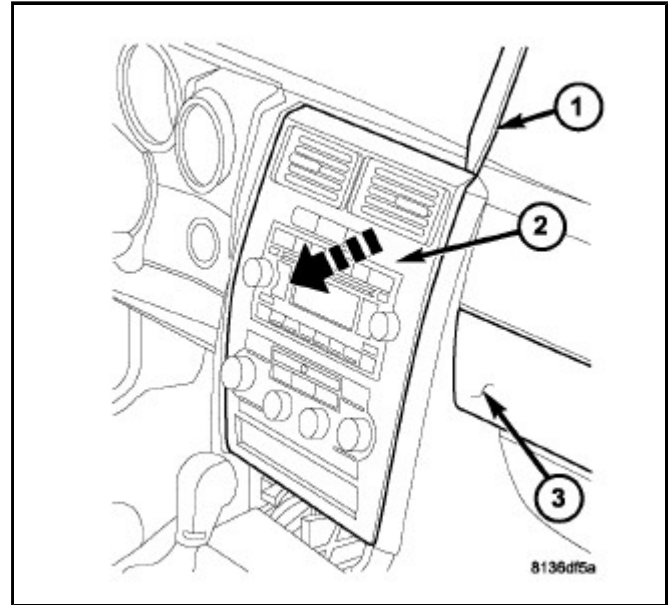
1. Before proceeding with the following repair procedure, review all warnings and cautions.
2. Using a trim stick C-4755 or equivalent (1), remove the center bezel (2) from the instrument panel (3) by releasing the snap retainers from the instrument panel.
